ANNUAL REPORT

ARCHÆOLOGICAL DEPARTMENT

SOUTHERN CIRCLE, MADRAS

1915-1916

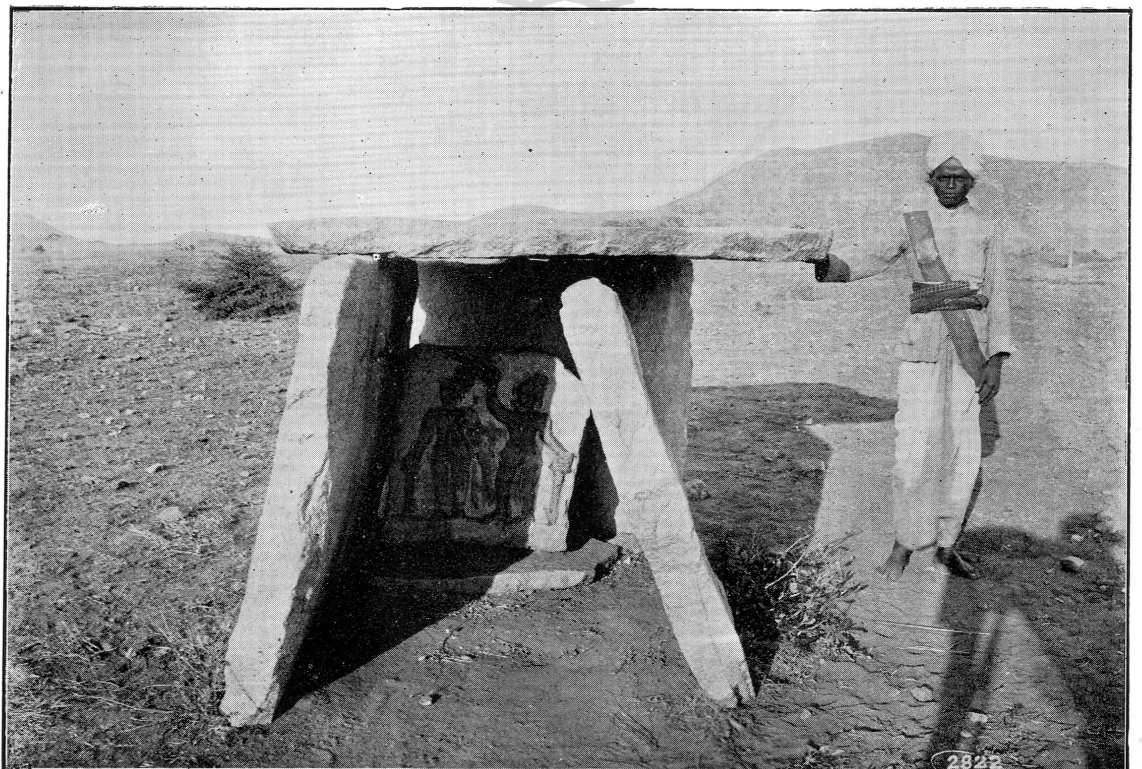
PLATE II (b)

Hero-shrine at Rayadrug, Bellary district.

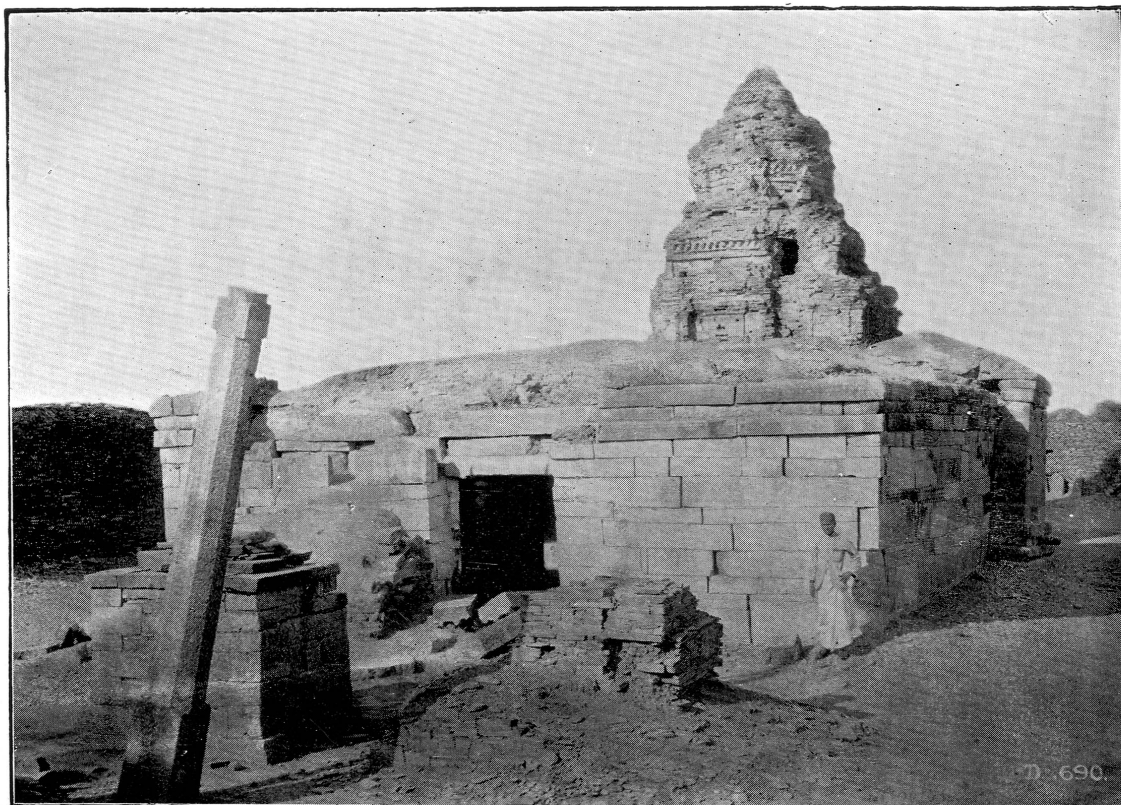
PLATE V (a)

Narasimha temple at Peddamudiyam, Cuddapah district.

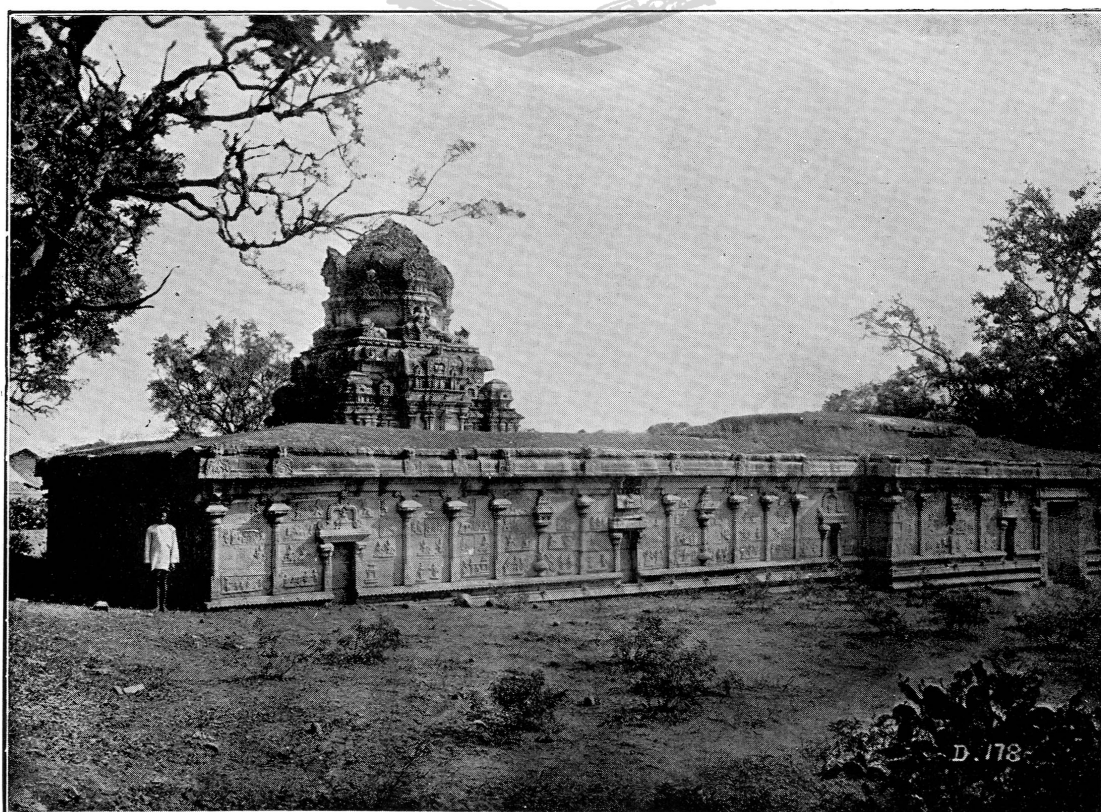
PLATE V (b)

Siva temple at Penukonda, Anantapur district.

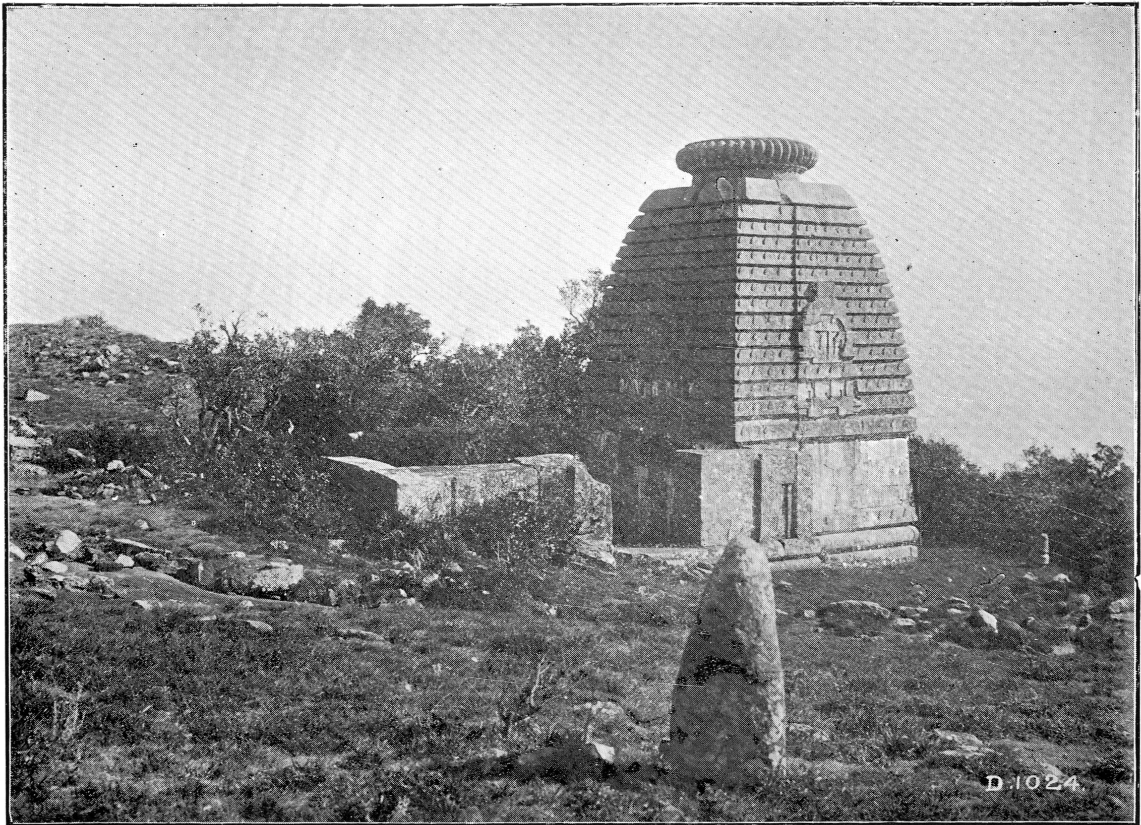
PLATE XI (a)

The Yudhisthira temple, Mahendragiri.
